Technical Bulletin

Subject: Horn, Sound is Distorted

Number: 97-03

Model(s): EuroVan

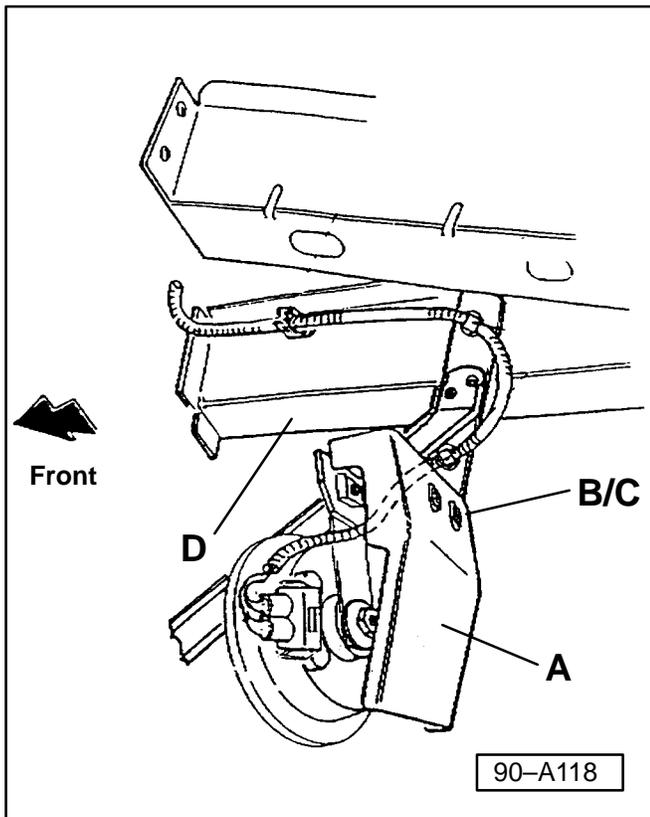
Horn, sound is distorted.

May be caused by water in horn.

- Replace horn.
- Install splash shield -A- below long member using the following parts.

Item	Description	Part No.
A	Splash Shield	701 951 203
B	Screw Washer	N 013 967 1 N 904 995 01
C	Nut	N 045 427 1
D	Long member	NPN
