# Dealer Service Bulletin

NO.: 7SB001-02-01A

**AFFECTED:** 1995-2000 Rialta motor homes

**SUBJECT:** VW Eurovan Chassis Oil Filter Access Improvement

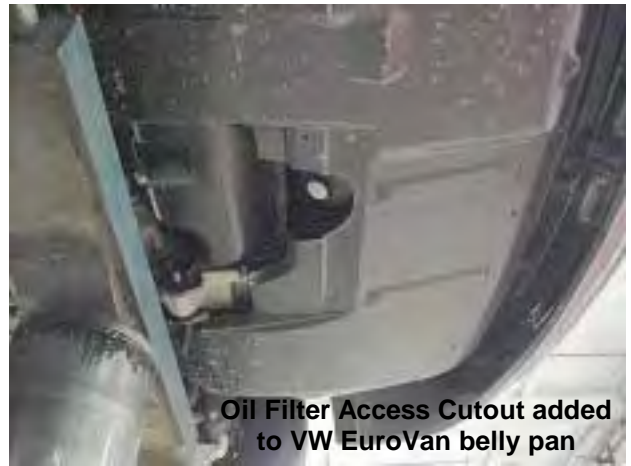
An access may be added to the belly pan as shown in the attached photos using the cutout template included at the end of this bulletin.

**Oil Filter Access Cutout added to VW EuroVan belly pan**

- Make a photocopy of the cutout pattern to cut out along the lines.
- Remove belly pan from vehicle and place bottom-side-up on floor or bench.
- Align pattern with contours of belly pan rear edge and trace with scribe or marker.
- Remove marked cutout area with saw or 'nippers'.
- File edges of newly created opening smooth to avoid personal injury.
- Install protective edge trim strip supplied to customer (p/n 115870-01-700) to perimeter of opening.
- Reinstall belly pan.

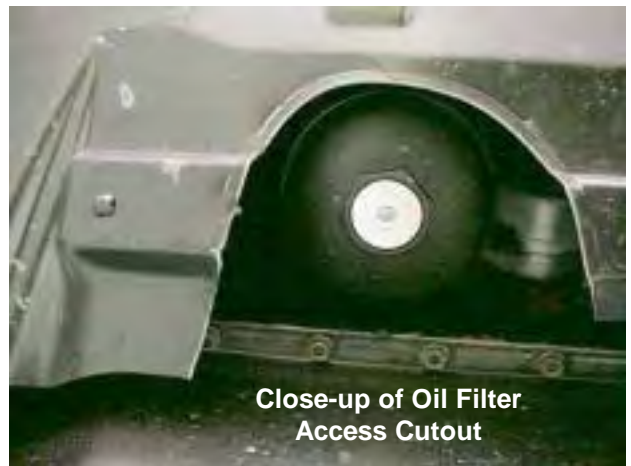
**Close-up of Oil Filter Access Cutout**

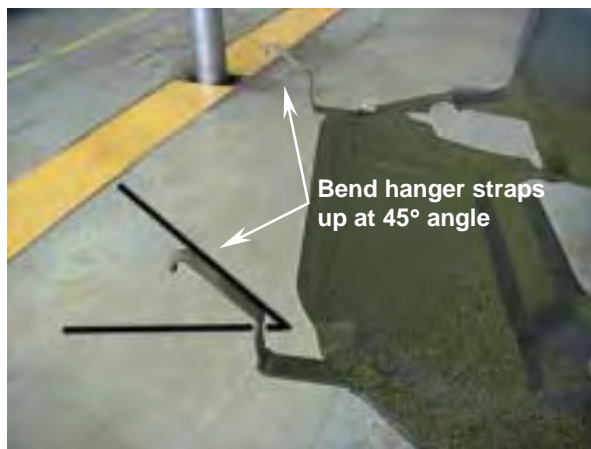
The belly pan attachment hinges (hangers) may be modified by bending as shown. This modification allows removal of the swing-down type belly pan by simply jacking the front end slightly, without having to raise the vehicle on a hoist.

- Remove belly pan from vehicle and place bottom-side-down on floor or bench.
- Use pliers or other gripping tool to change the angle of both attachment hangers to 45° as shown on template at end of bulletin.
- Reinstall belly pan.
