Dealer Service Bulletin

NO.: 7SB007-01-02A

AFFECTED: Coaches equipped with Deluxe Sound Systems

SUBJECT: Noise Diagnostics – Deluxe Sound Systems

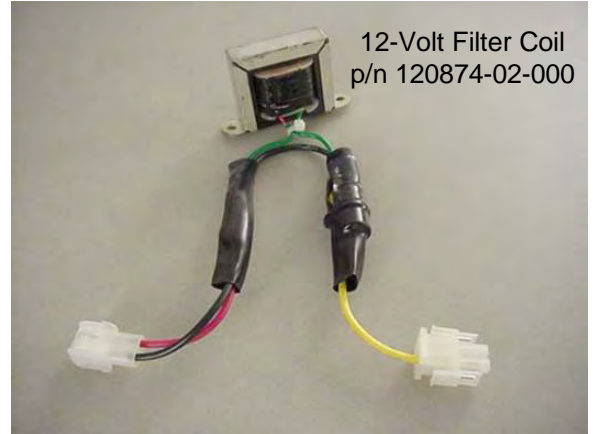
If both the radio and TV emit a hum, buzzing or clicking noise (especially if the engine is running) the root of the interference is most likely the 12-volt constant source. Install a 12-volt DC filter (top photo) in the constant source wire CCS or GT at the pigtail connector on the rear side of the dash radio. Make sure the red wire is connected to the battery side and the yellow wire to the load side. Also tap a ground wire into the black lead wire for the filter to work properly.

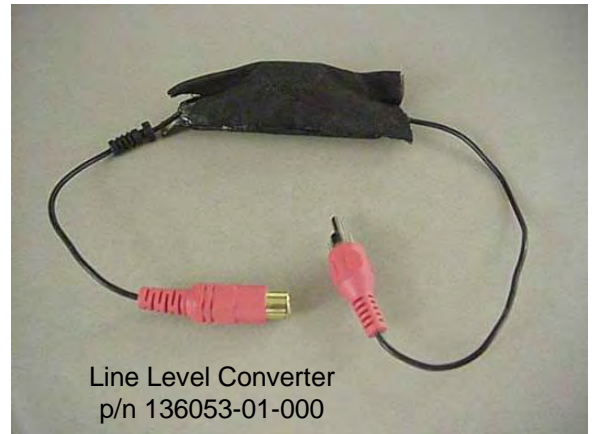
If the hum is present only when the TV is on, unplug the audio output wire from the back of the TV. If the hum goes away, install a line level converter (bottom photo) in-line between the amplifier and the TV audio input cable at the amplifier.

If the hum is still present with cable unhooked from the back of the TV then replace the audio cable from the TV to the amplifier making sure the replacement is shielded cable.
