Technical Bulletin

Subject: **Driver's Side Airbag, On Board Diagnostic (OBD)**

Number: **00-02**

Date: **Apr. 24, 2000**

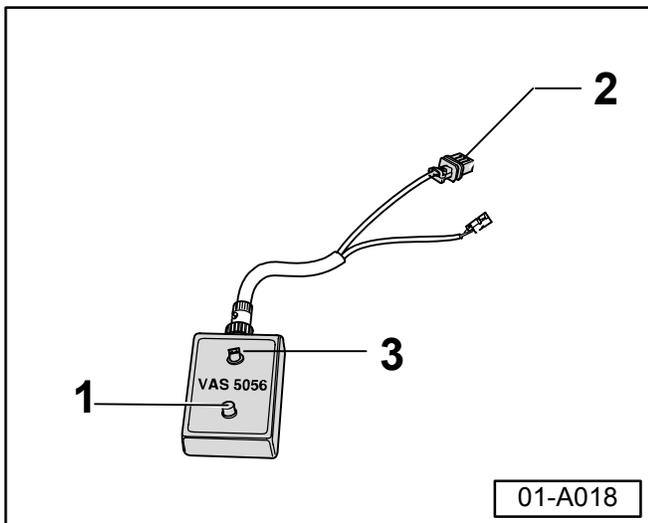
VAS 5056 test box, components

- 1 - Button
 - Used to simulate short circuit in harness through connectors.
- 2 - Adapter harness (VAS 5056/2) with connectors for inert igniter #2.
 - Used to connect inert igniter #2 to airbag harness
- 3 - Igniter connector on inert igniter #1.
 - Used to simulate correct resistance of igniter at airbag or seat belt.

It is possible to use VAS 5056 in conjunction with VAG 1551/1552 or VAS 5051 to diagnose airbag system faults.

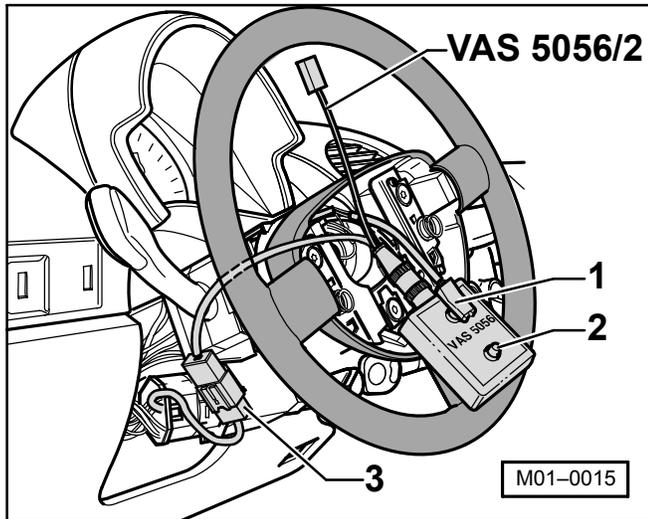
Airbag, connecting test box to driver's airbag components, example

- Remove driver-side airbag and steering column switch lower trim.
- ◀ - Connect airbag igniter connector -1- to inert igniter #1.
- View display. See Evaluating display group 001 for specific diagnostic instructions. If diagnosis is not completed, disconnect air bag igniter connector to inert igniter #1 and proceed to next step.
- Separate airbag wiring harness from airbag spiral spring/return spring with slip ring connector,
- Connect adapter harness with connectors for inert igniter #2 -3- (VAS 5056/2) to airbag harness. See Evaluating display group 001 for specific diagnostic instructions. If diagnosis is not completed, proceed to next step.
- Press button -2- to simulate short circuit in airbag harness through connectors. Repair as directed.

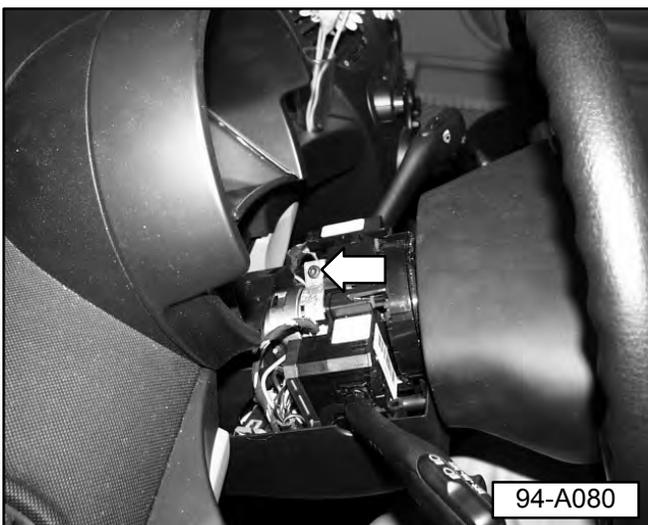
Airbag spiral spring/return spring with slip ring, adjustment

Perform following procedure when directed or when one of following symptoms occur:

Scratching or grinding noise is heard.

- Steering column switch/spiral spring is either misaligned right or left or positioned too high on steering column.

Clicking noise from steering wheel is heard.

- Steering column switch/spiral spring is positioned too low on steering column.

- Remove upper trim cover.
- ◀ - Loosen fastening screw -arrow-.

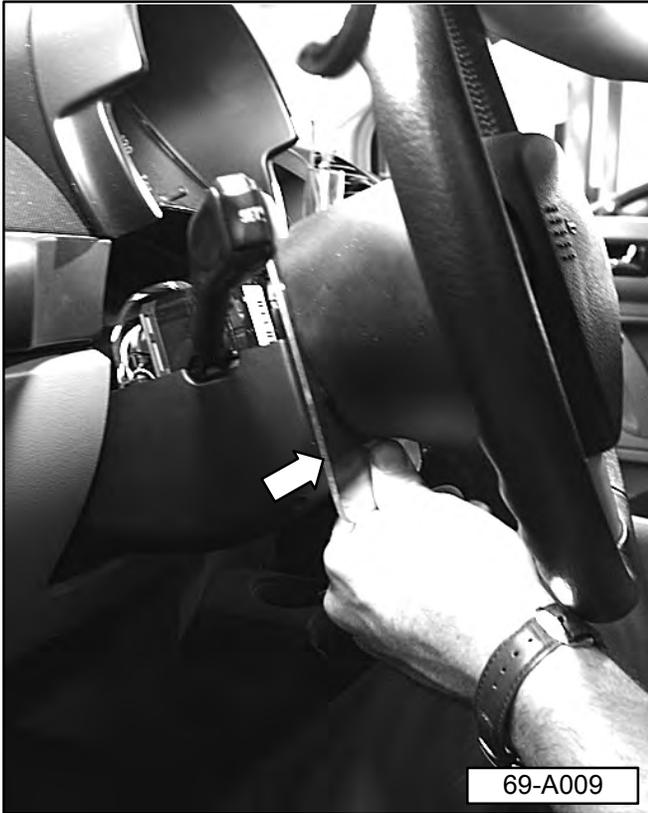
- Special Tool JC2000A or JC2000B (ESP vehicles) spacer gage is used for this procedure.
- ◀ - Place spacer gage between spiral spring and steering wheel as shown -arrow-.
- Make sure gage is against lip of spiral spring.
- Adjust steering column switch/spiral spring up against spacer gage at steering wheel as necessary.
- Make sure steering column switch/spiral spring is level horizontally.
- Make sure steering column is centered in spiral spring through-hole.

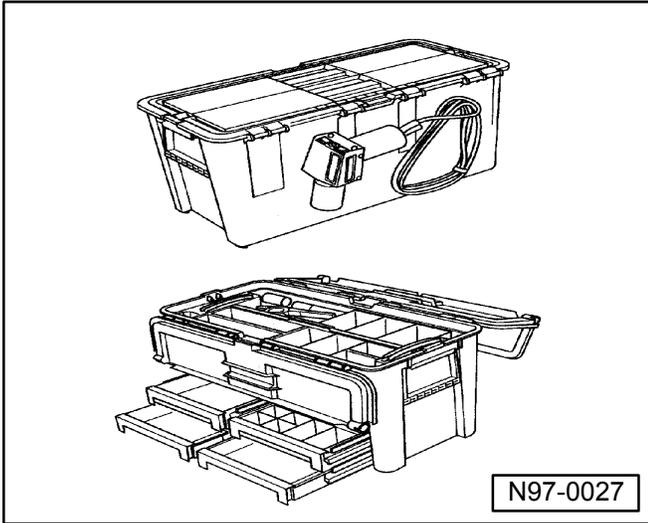
Wire harness, repair

- ◀ – Use only VAS 1978 Wire Harness Repair Kit.
- If wire harness cannot be repaired using this procedure and materials contained in VAS 1978, replace wire harness.

No other procedure or materials, other than those in VAS 1978, may be used for wire harness repairs, specifically soldering, wire nuts, generic repair kits, etc.

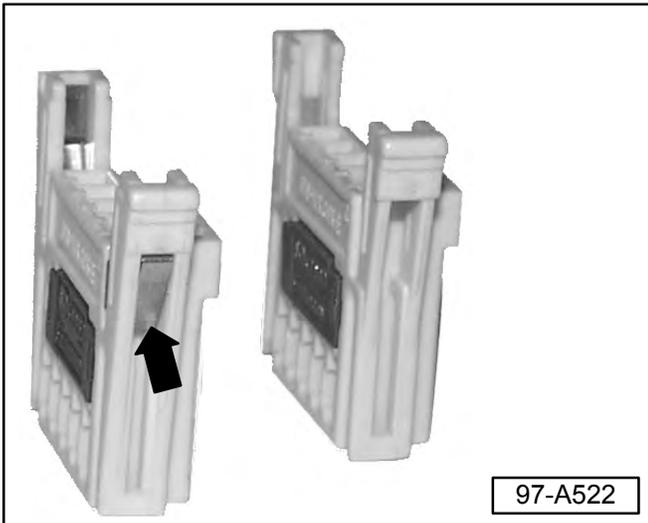
Airbag spiral spring/return spring with slip ring harness, connector repair

- ◀ A metal spring tensioner -arrow- has been added to help hold housing lock tabs in place.

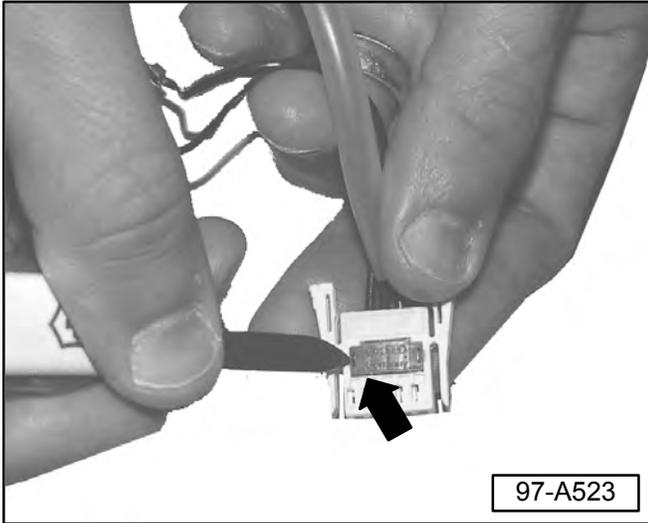
- ◀ – Carefully pry violet secondary lock mechanism -arrow- away from connector housing using small screwdriver.
- Carefully pull terminals out of connector housing.
- To install into new connector, push terminal into appropriate socket as far as possible.
- Push violet secondary lock mechanism into connector housing until it snaps.
- Pull gently on terminals to ensure proper engagement.

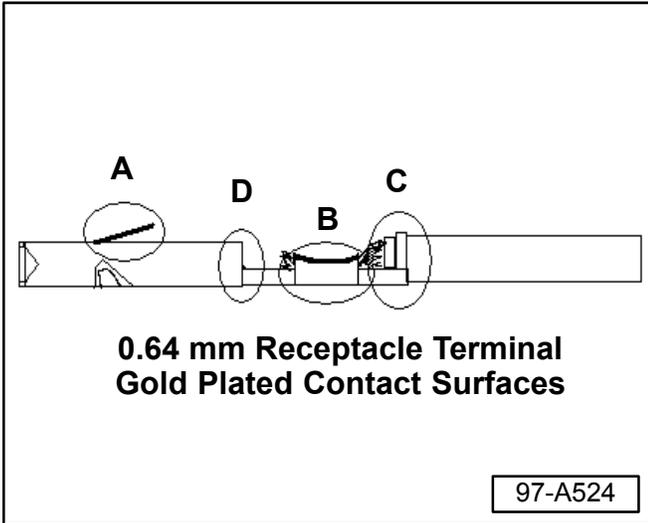
Airbag spiral spring/return spring with slip ring harness, terminal inspection

- ◀ Replace terminal when one of following conditions occur:
 - Terminal is bent or unintentionally deformed.
 - Terminal is cracked or torn at crimped areas -B- and -C-.
 - Wire insulation has been drawn into core crimp -B-.
 - Material is cracked at transition bend -D-.
 - Terminal coating shows signs of moisture or "greasy" coating. Terminal surface should be bright and shiny.

Primary lock tab(s) -A- should be straight and stand away from the terminal.

During terminal extraction, primary lock tab(s) may have been pressed into terminal. Straighten using sharp edge to carefully lift tab.
