# Technical Bulletin

Subject: **CD Changer, Grounding**

Number: **95-04**

Model(s): **All with Panasonic CD Changer**

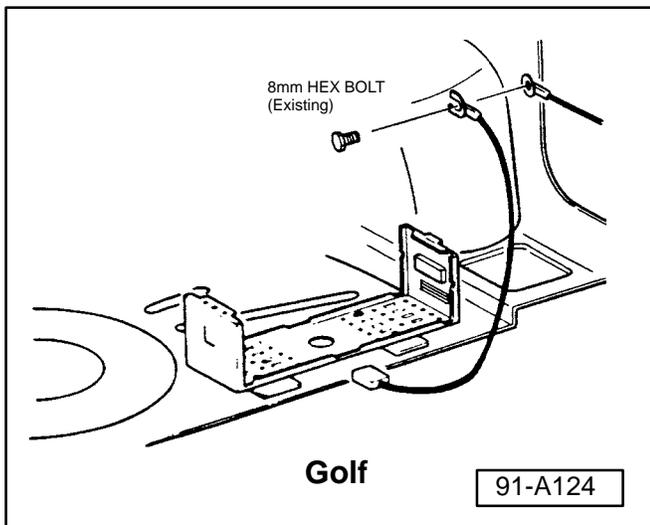
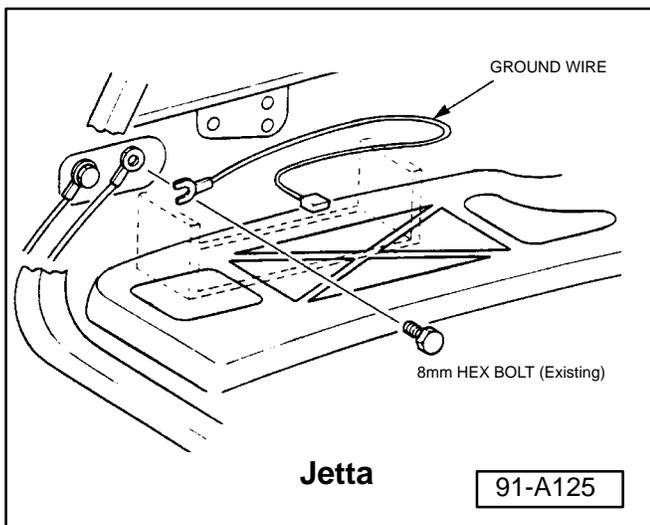
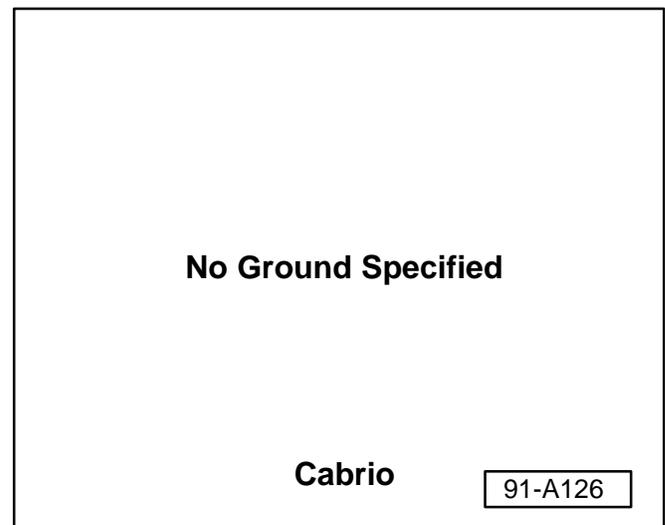
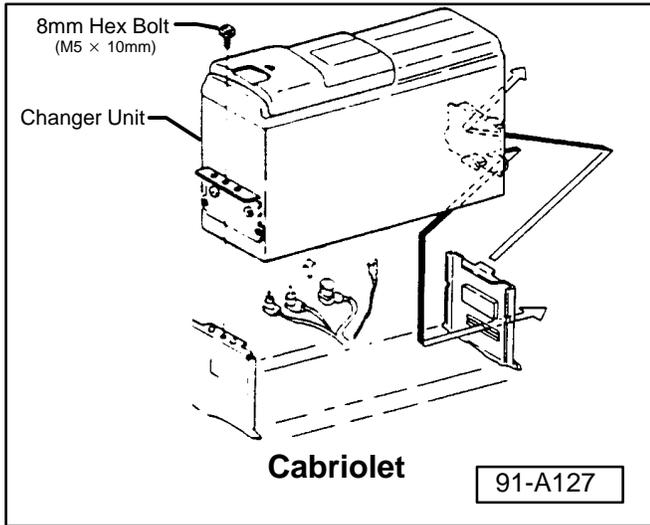
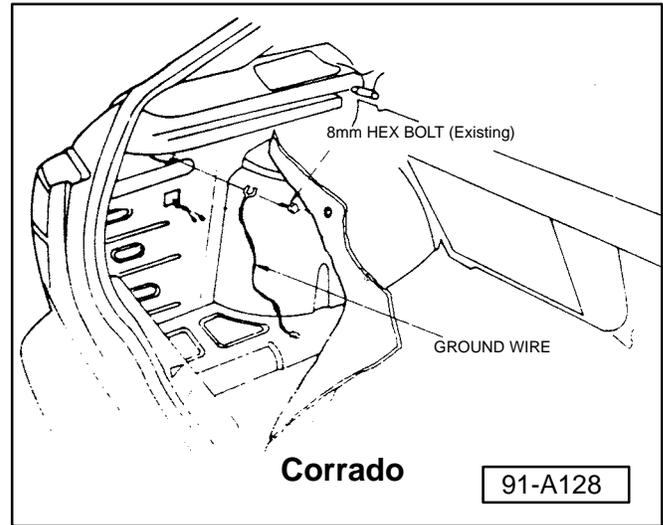
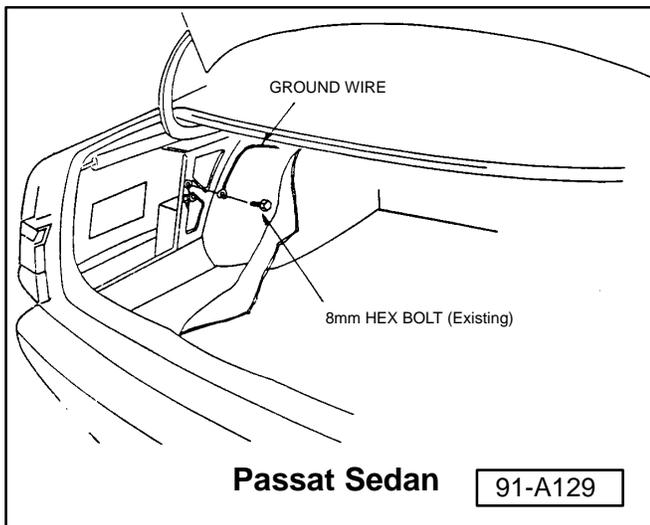
Noise while using the CD changer can be caused by the installation of an additional ground wire.

This ground wire can introduce noise into the system and is not necessary for the CD changer to function.

- Using the following illustrations as a guide, inspect for the additional ground wire in the locations shown.
- Remove additional ground wire.

**When installing NEW CD changers DO NOT install this additional ground wire.**
