WIRING DIAGRAM COACH  
 (WIRE ASM 141381)

COPYRIGHT 2003 WINNEBAGO INDUSTRIES, INC. <b>WINNEBAGO</b> 04 222HD		MATERIAL:
DFT#	DATE	UNSPECIFIED TOLERANCES ARE:
CMR	DATE	ANGLE
P E	DATE	ONE-PLACE (X.X)
M E	DATE	TWO-PLACE (X.XX)
DSNR	DATE	THIRD ANGLE PROJECTION
LAYOUT NO.	TITLE	
WIRING DIAGRAM-BODY, 12V		
DIA #	SCALE	NOTE
ALL DIMENSIONS ARE IN MILLIMETERS	SHEET	OF 2
REF: 141384 A	NO	144798

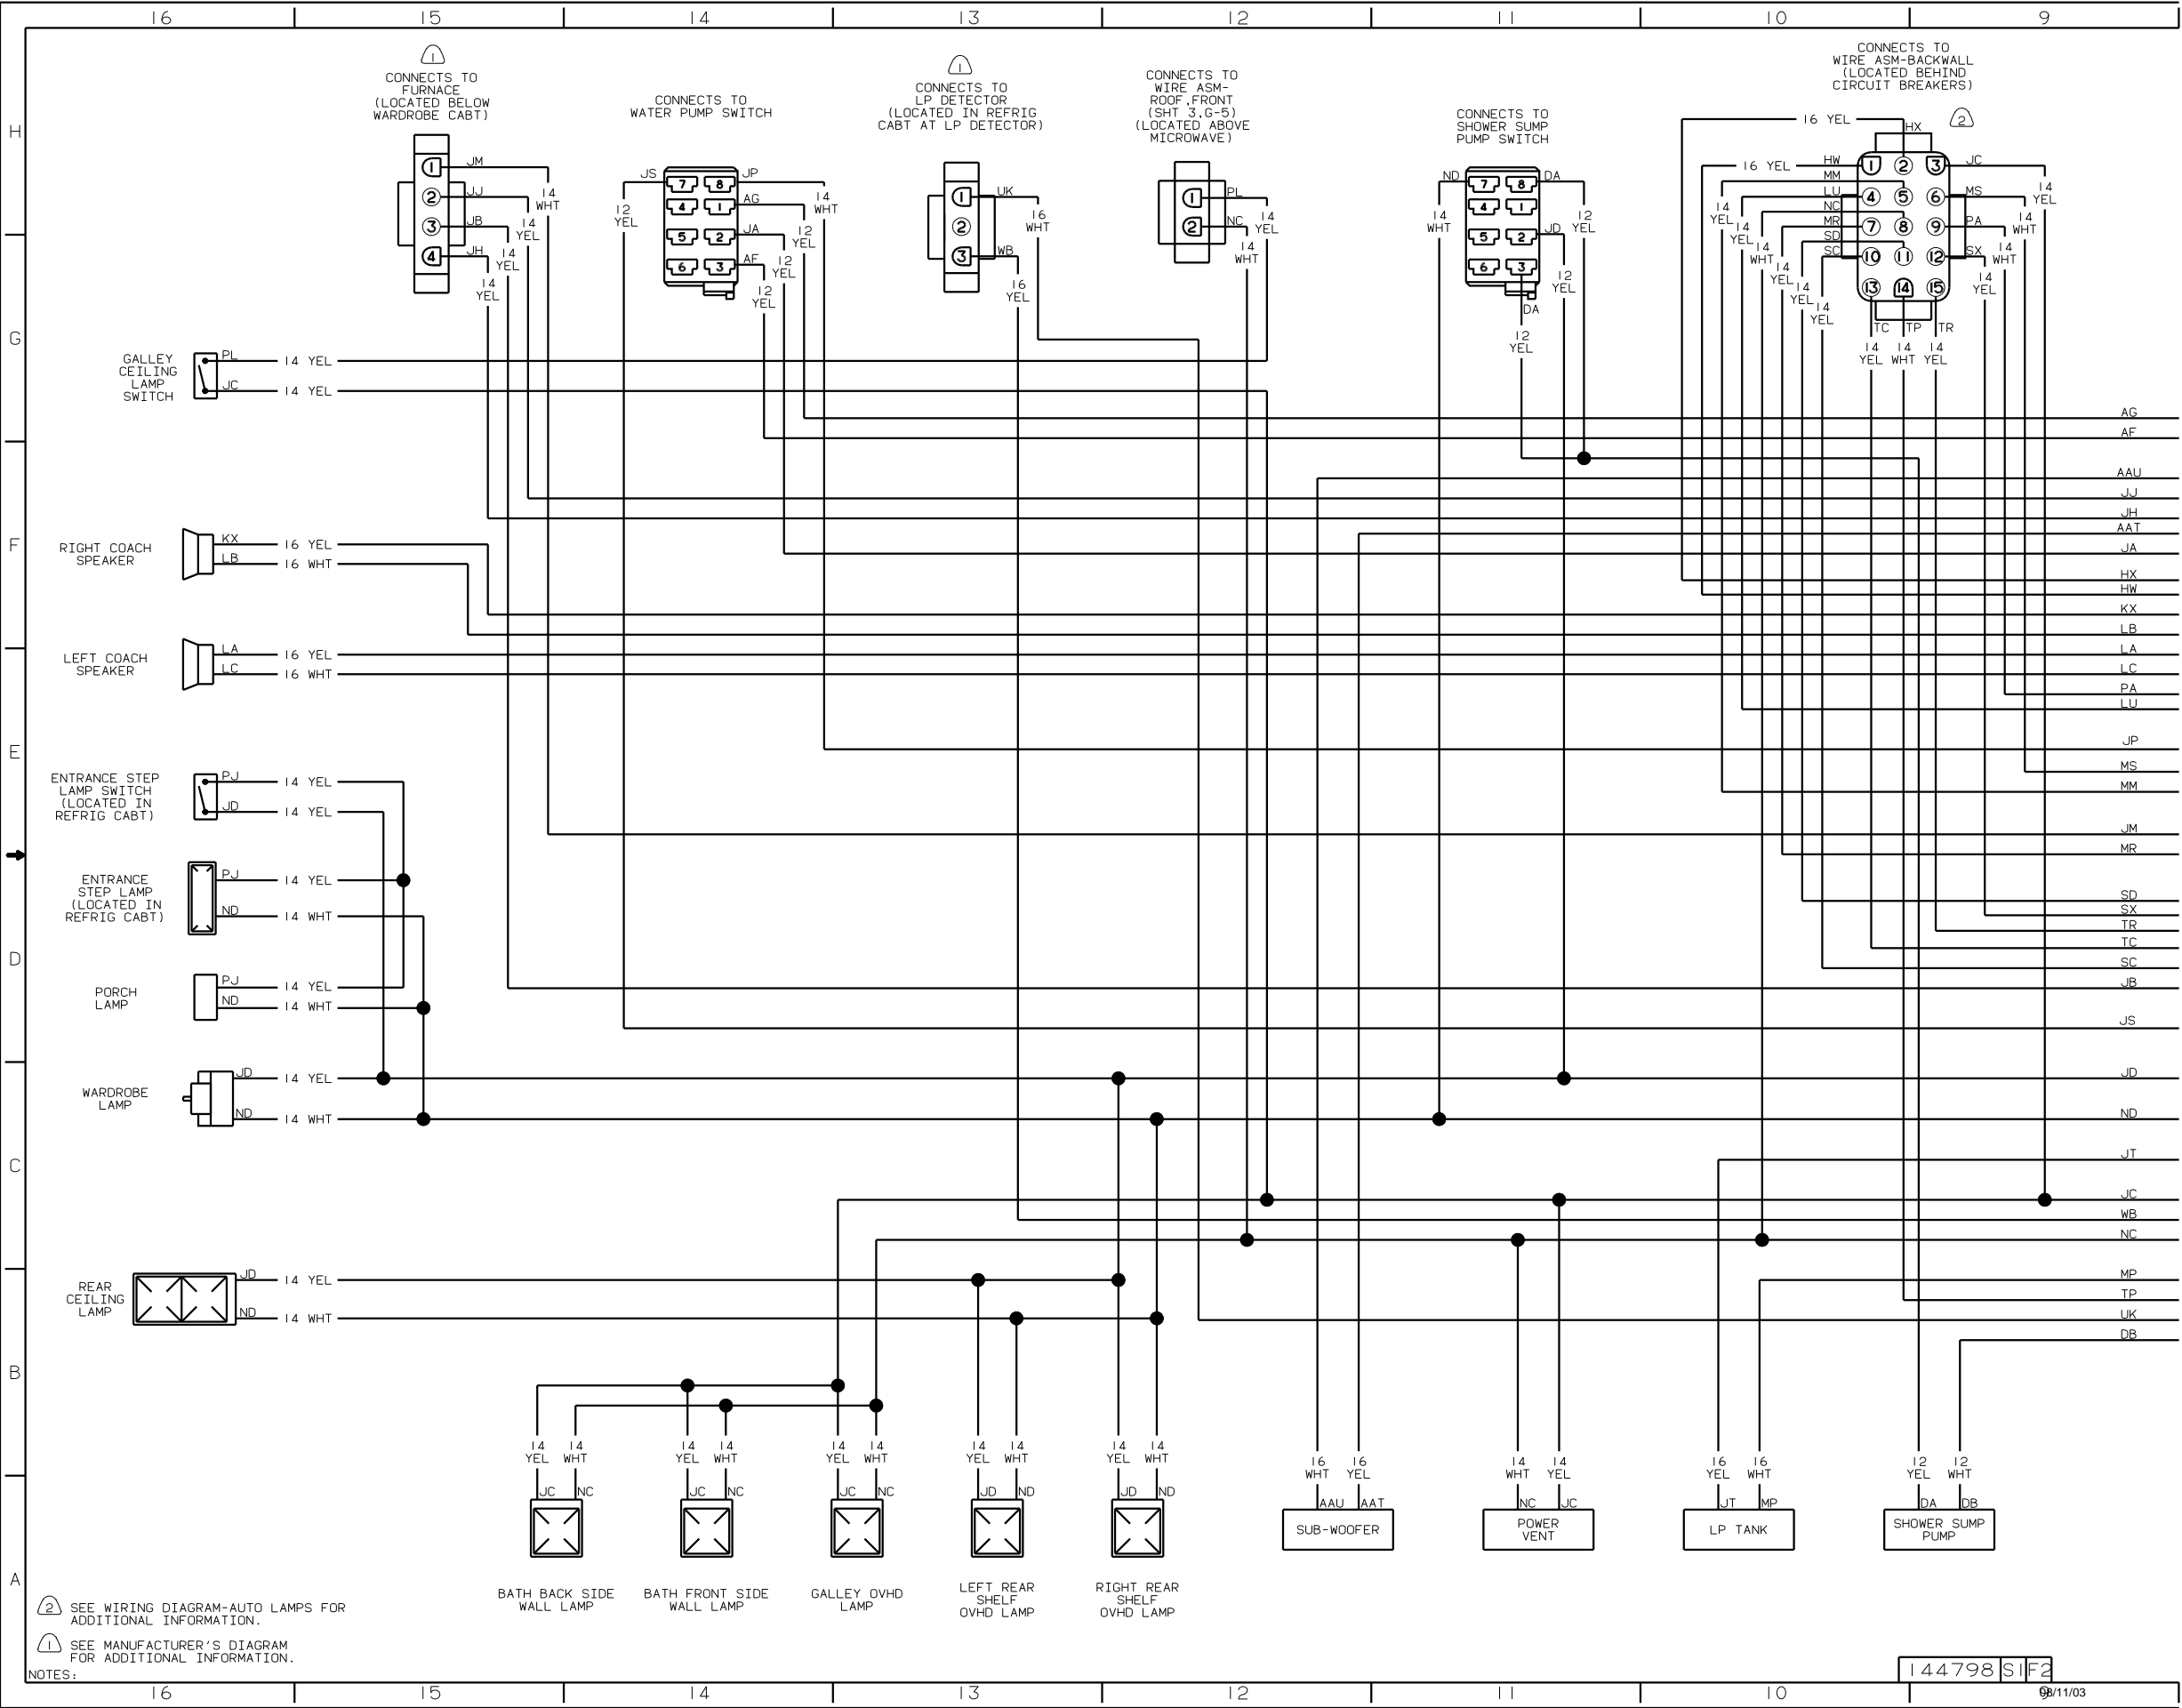
①  
CONNECTS TO  
FURNACE  
(LOCATED BELOW  
WARDROBE CABT)

CONNECTS TO  
WATER PUMP SWITCH

①  
CONNECTS TO  
LP DETECTOR  
(LOCATED IN REFRIG  
CABT AT LP DETECTOR)

CONNECTS TO  
WIRE ASM-  
ROOF FRONT  
(SHT. 3, G-5)  
(LOCATED ABOVE  
MICROWAVE)

CONNECTS TO  
SHOWER SUMP  
PUMP SWITCH

CONNECTS TO  
WIRE ASM-BACKWALL  
(LOCATED BEHIND  
CIRCUIT BREAKERS)
