Please give copies to all Technical Bulletin

Subject: Heating and Ventilation Controls, Replacing Fresh Air Group: 85

Control Lever Light -L16-

Number: 99-02

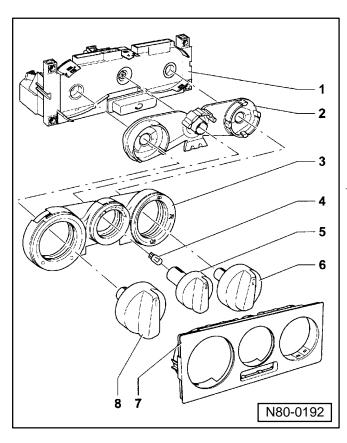
Heating and ventilation control assemblies replaced due to inoperative fresh air control lever light -L16-.

DO NOT replace entire control assembly. Replace lever light as follows:

- Remove fan speed control knob -5- using pliers with suitable plastic or rubber protection on jaws (note position of knob).
 - Remove bulb -4- using a piece of rubber hose approx. 4mm inner dia. (press hose onto bulb far enough to grip bulb and remove).
 - Install new bulb Part No: N 017 751 2 (press into hose only slightly, then install into bulb socket).

- Turn on vehicle lights and check operation of bulb.
- Reinstall fan speed control knob -5- in same position as removed (check operation).
