SUBJECT: Campaign #92 – Am-Safe Seat Belt Buckle

INSTRUCTIONS TO PERFORM CAMPAIGN #92

Replacement of Seat Belt Buckle Assembly on a Limited Number of Class A Motorhomes and Rialta Motorhomes

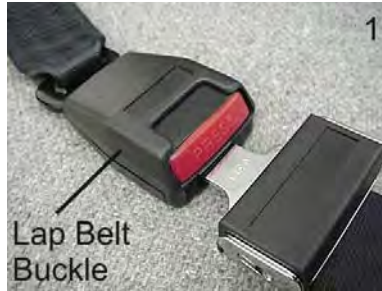
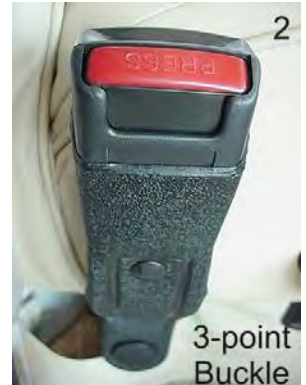
The Am-Safe seat belt buckle involved in this campaign is an end-release style buckle identified by a red release button with the word “PRESS” embossed onto it as shown in photos 1 and 2.

Buckles with a center button release containing an oval globe logo are not included in this campaign.

This campaign involves replacing only the buckle-end of the belt— not the tongue-end.

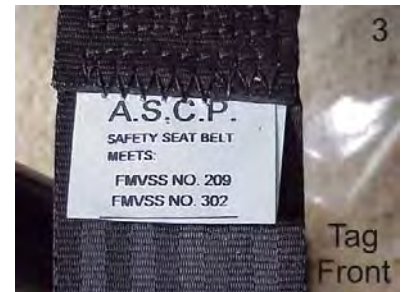
- Look for the product tag label near the anchor bolt bracket of the tongue-end belt assembly as shown in photos 3 and 4.
- If the belt also includes an extension (shown in photo 5) inspect the part number and manufactured date of the extension as well.
- Inspect the **part number** of the belt assembly (NOT the model number). **The buckle assembly must be replaced if the tag contains a part number and date code shown in the chart below.** Defective buckles will have one of the part numbers shown and date codes in MMDDYY (2-digit month, date, year) sequence.

This photo shows the 'front' of the tag.

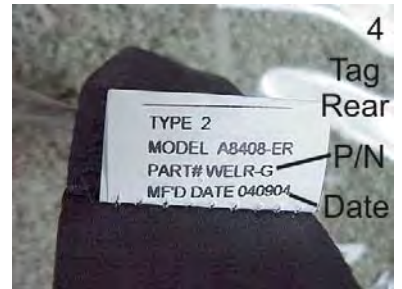
This photo shows the 'back' of the tag, which includes the pertinent information, including model no., part no., and date of manufacture.

Assembly Type	Am-Safe Part No.	Replace belts within range of Mf'd Date:	Order Wbgo Part No.
three-point	WELR-G	9-5-03 to 3-22-04	091990-04-792
three-point	I-4024	9-8-03 to 3-22-04	091990-04-792
three-point	I-1208	12-12-03	118350-04-792
lap belt	ODELR-R	9-8-03 to 3-22-04	118350-04-792
lap belt	90ER	9-8-03 to 3-22-04	114258-04-792
extension	I-1331	1-5-04	091990-01-792

- **NOTE:** If the part number is not shown on the chart, no replacement is required. If the recall has already been performed, there will be a tag near the buckle on the replaced belt. If a front seat 3-point belt buckle has been replaced, there will be a hole punched into the plastic belt sheath mounted to the side of the seat.
