(CAN 110V WIRING)  
 (DOUBLE BED) (TWIN BED)

US 110V WIRING  
 (DOUBLE BED) (TWIN BED)

OF IN		DATE	UNDESIGNED TOLERANCES ARE	MATERIAL
CHP	DATE	WHOLE ORN 101	ONE-PLACE 19.01	
DYE	DATE	HQ-PLACE 19.003	ANGLE	
D/E	DATE	INDU. WELD PRODUCTION		
CONP	DATE			
LAINT	DATE			
TITLE: WIRING DIAGRAM-BODY 110V				
REV #	SCALE	NOTE	BY	CHK
ALL DIMENSIONS ARE IN MILLIMETERS	SHEET	1	OF	1

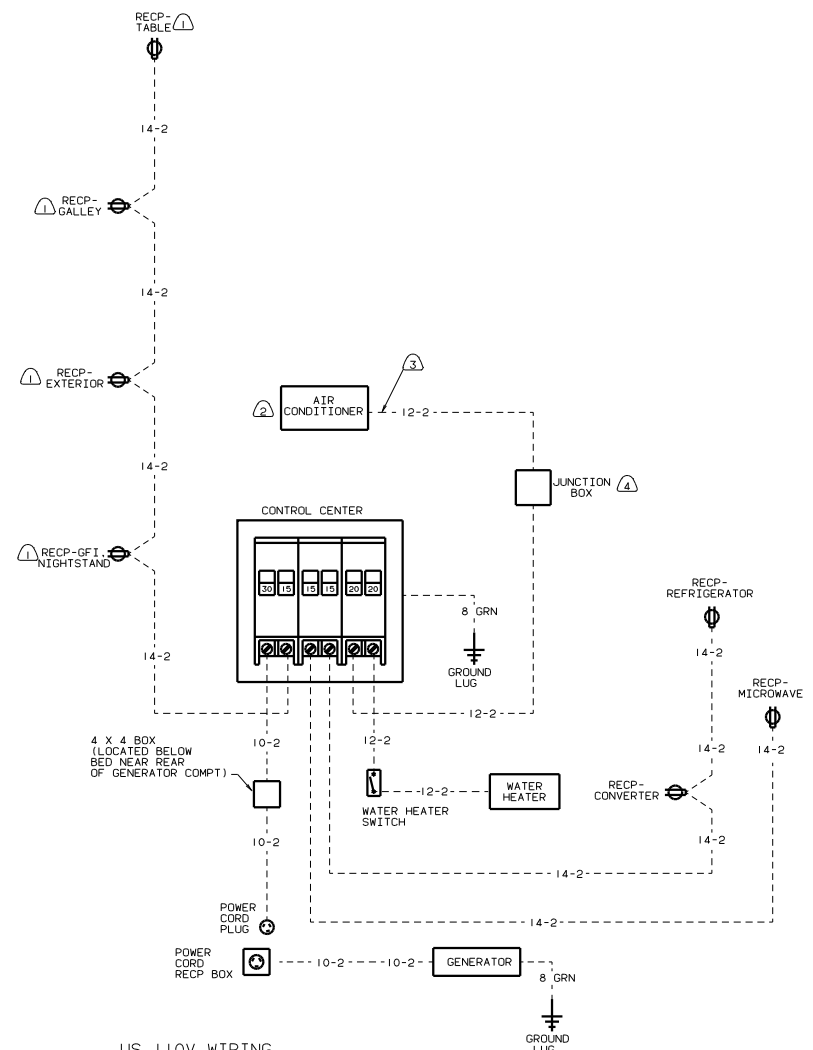
- (4) NOT USED WITH 29K A/C. ROOF TWO 13,500.
- (3) WIRE ROUTED THRU ROOF.
- (2) WITH AIR CONDITIONER.
- (1) PROTECTED BY GFI RECP.
